Preliminary report

Crash involving Malaysia Airlines Boeing 777-200 flight MH17

Hrabove, Ukraine - 17 July 2014

The Hague, September 2014

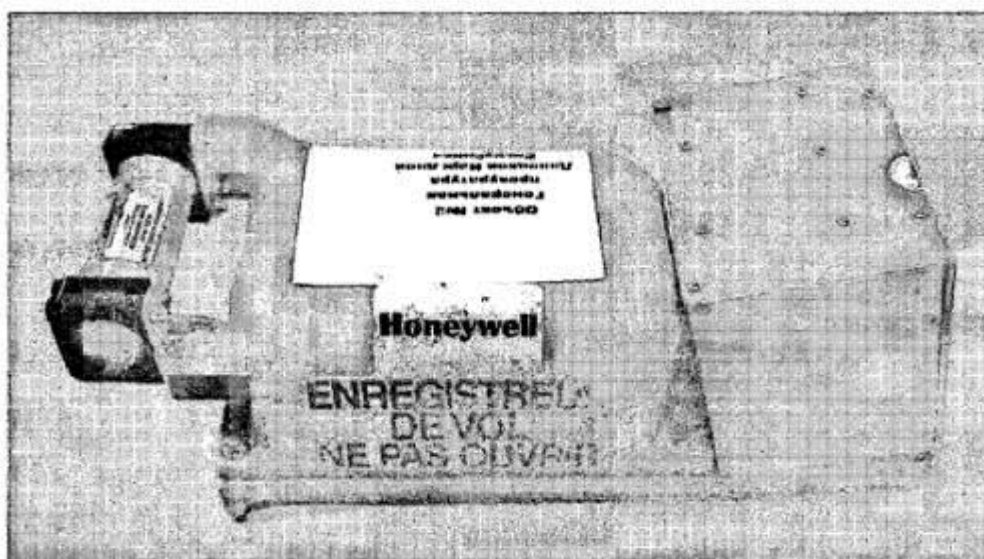
Figure 4: Cockpit voice recorder. (Source: AAIB)

The housing of the CVR (figure 4) had been damaged and, although the model and serial numbers were unreadable on the data plate, the serial number 1366 - matching the one provided by Malaysia Airlines - was found stamped on the underside of the chassis. The external damage found on the CVR is consistent with impact damage, the internal memory module was intact. The recording capacity of this recorder is 30 minutes.

The full 30 minutes were successfully downloaded and contained valid data from the flight.

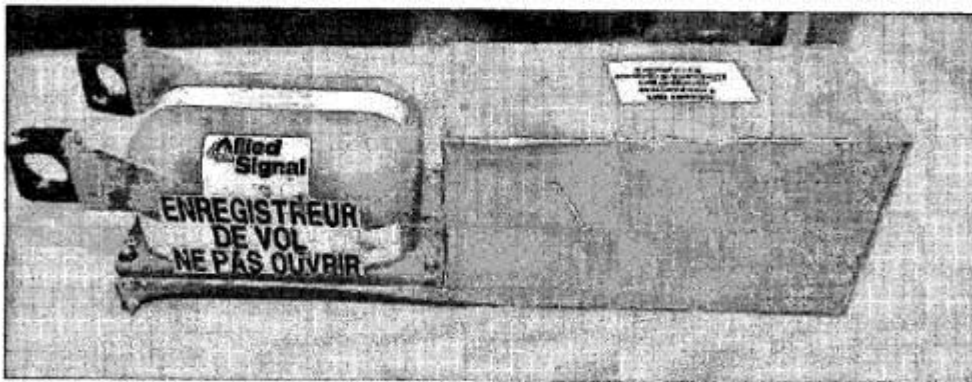
Figure 5: Flight data recorder. (Source: AAIB)

The label on the housing of the FDR (figure 5) showed that it was Allied Signal Model Number 980-4700-003 with Serial Number 2196. These details matched the details provided by Malaysia Airlines. The recorder was found damaged but the internal memory module was intact. The external damage found on the FDR was consistent with impact damage. The FDR, which can record 25 hours of operational data, was successfully downloaded and contained valid data from the occurrence flight.

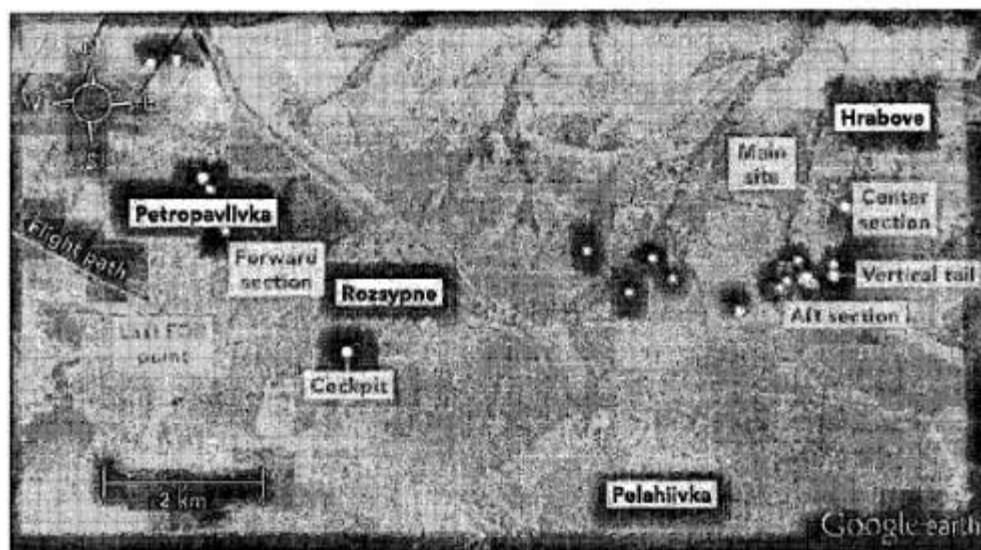
The aircraft wreckage, identified from the on-site photographs and satellite images, consisted of many large and small pieces distributed over an area of approximately 10 km by 5 km (figure 6). Fuselage pieces, cargo and baggage were scattered throughout the wreckage site. There were many additional unidentified pieces that are not shown in the figure. For easy reference the wreckage site has been divided into sections as shown in figure 6. These sections match with the aircraft sections shown in figure 7.

Figure 6: The last location of the aircraft in flight taken from the FDR. Wreckage distribution is grouped per section of the aircraft (Source: Google Earth, wreckage information Dutch Safety Board).

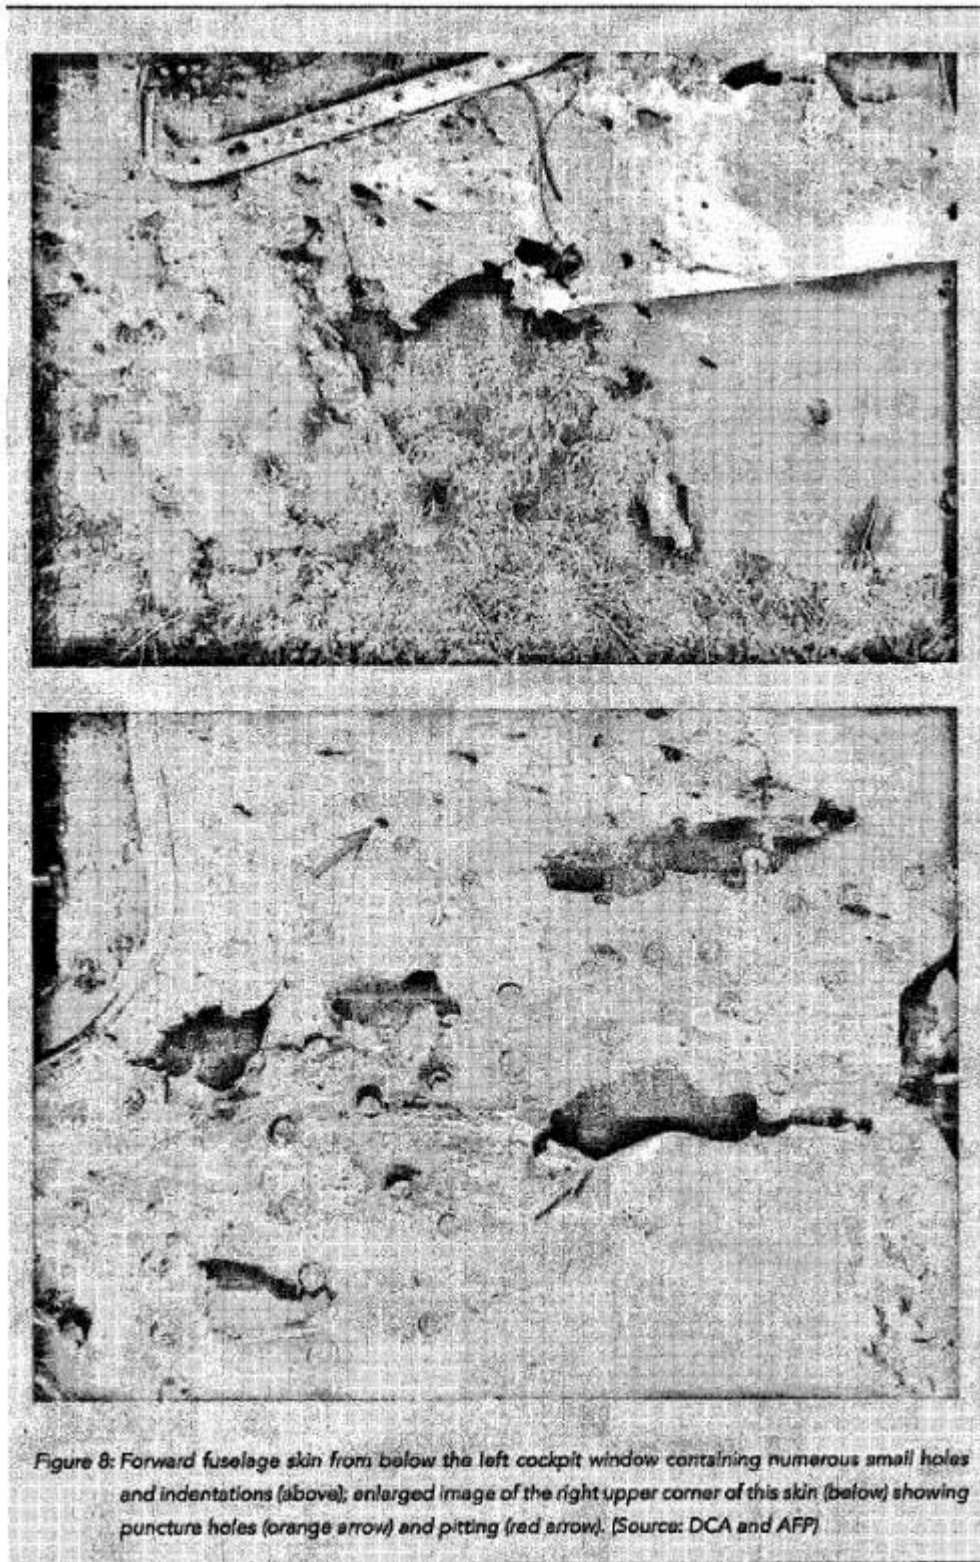
Photographs from the some wreckage showed that a number of pieces contained multiple holes and indentations. An example of a piece of wreckage containing such damage was a piece of skin from below the left cockpit window (figure 8) found in the town of Petropavlivka.

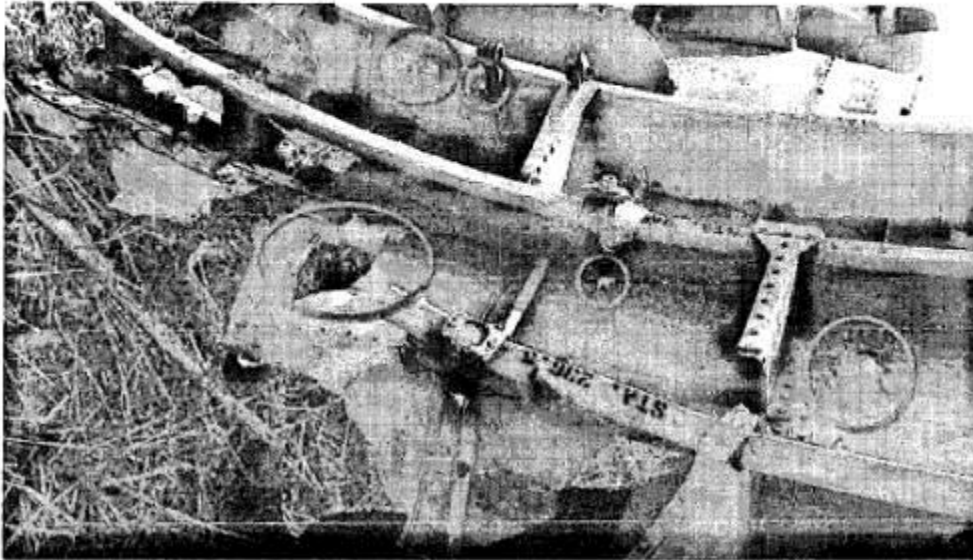
Around 1.7 km north of the position where the cockpit window structure was found, was a section of the cockpit roof also showing holes indicating penetration from outside (figure 9).

Figure 9: Part of the inside cockpit roof, indicating penetration with objects from outside. (Source: DCA)

Noting that the investigation team has not yet had the opportunity to recover these components for forensic examination, photographs from the wreckage indicated that the material around the holes was deformed in a manner consistent with being punctured by high-energy objects. The characteristics of the material deformation around the puncture holes appear to indicate that the objects originated from outside the fuselage.

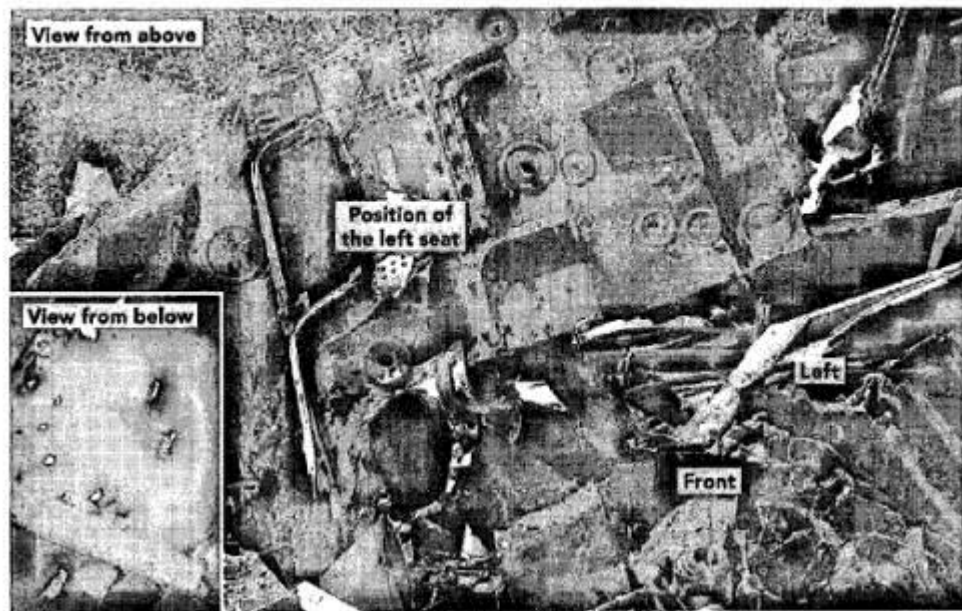
Puncture holes identified in images of the cockpit floor suggested that small objects entered from above the level of the cockpit floor (figure 10).

Figure 10: Cockpit floor with floor parts showing puncture holes (red circles) coming from above the floor.
(Source: NBAAI)

The pattern of damage observed in the forward fuselage and cockpit section of the aircraft was consistent with the damage that would be expected from a large number of high-energy objects that penetrated the aircraft from outside.

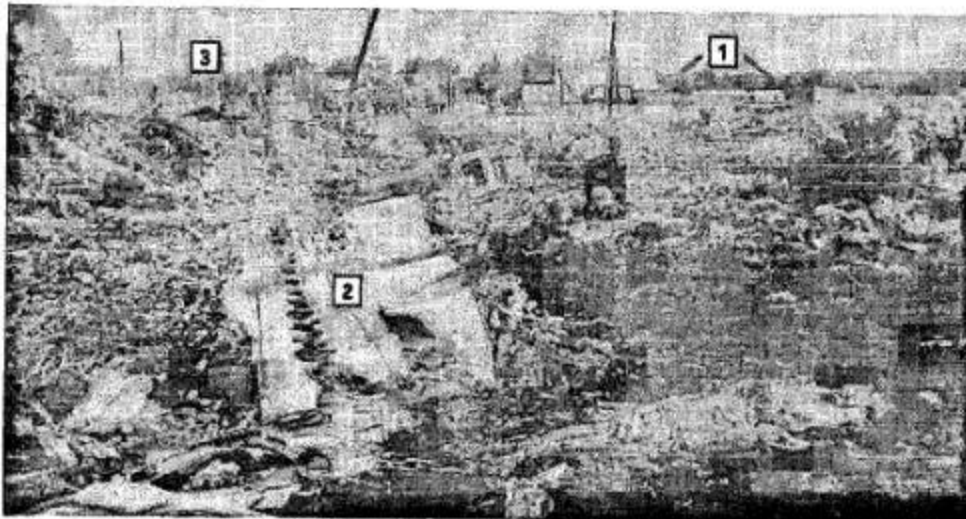
The main site was located at the south-western corner of the town of Hrabove, 8.5 km from the last recorded FDR position of the aircraft. This site contained parts of the wings, both engines, the main landing gear and a portion of the fuselage (figure 11). Aircraft parts distributed over the main site had been subjected to post crash fire.

Figure 11: Main wreckage site showing engine parts (1), wing with inspection hatches (2) and main landing gear (3). (Source: NBAAI)

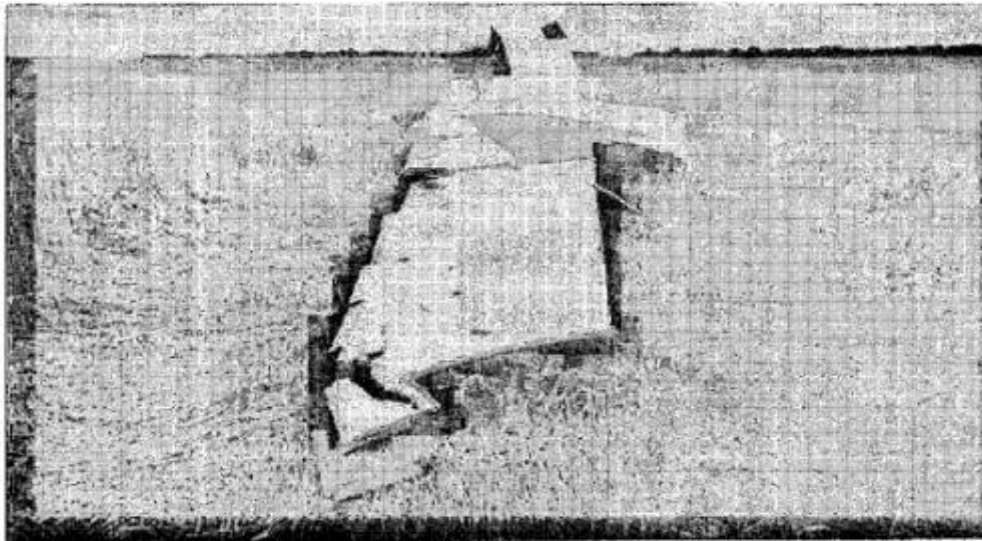
Figure 12: Vertical tail. (Source: DCA)

The vertical tail (figure 12) was located in a field to the south of Hrabove, approximately 8 km from the last recorded FDR position. The vertical tail was still attached to a portion of the upper rear fuselage. The rudder and a portion of the vertical tail's leading edge were not attached. The remains of the rear fuselage, horizontal stabiliser centre section, and items from the cabin were found about 100 metres north of the vertical tail.

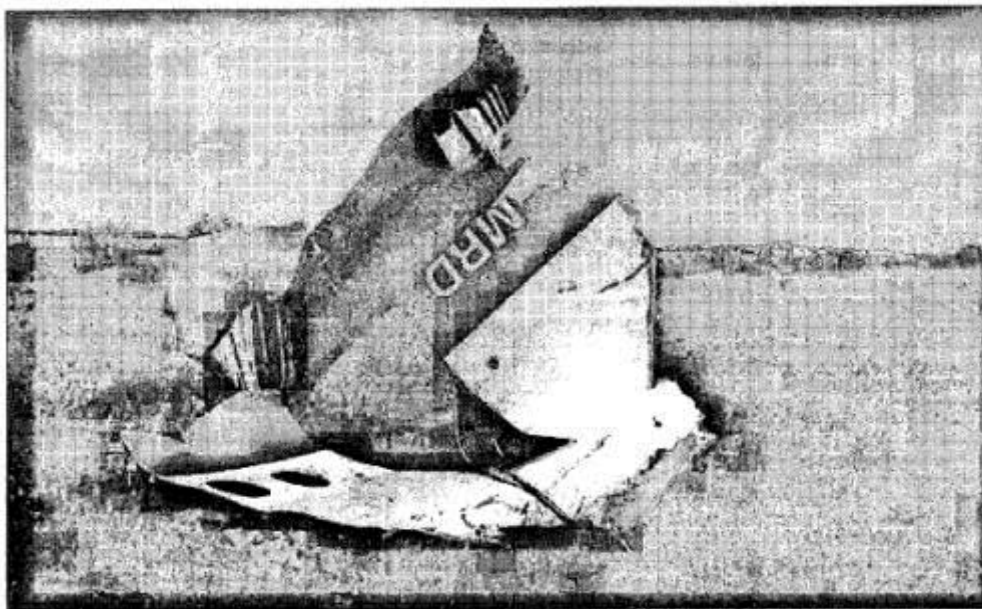
A section of aft fuselage skin from the right side (figure 13) was located 330 metres west of the vertical tail, and the left wing tip and right horizontal stabilizer were also in this location. The left horizontal stabilizer was found another 330 metres to the west.

Figure 13: Aft fuselage skin, right side, with partial registration of the aircraft. (Source: NBAAI)
