**Letter dated 4 March 2019 from the Secretary-General addressed to the President of the Security Council**

**Note by the Technical Secretariat**

**Report of the fact-finding mission regarding the incident of alleged  
use of toxic chemicals as a weapon in Douma, Syrian Arab  
Republic, on 7 April 2018**

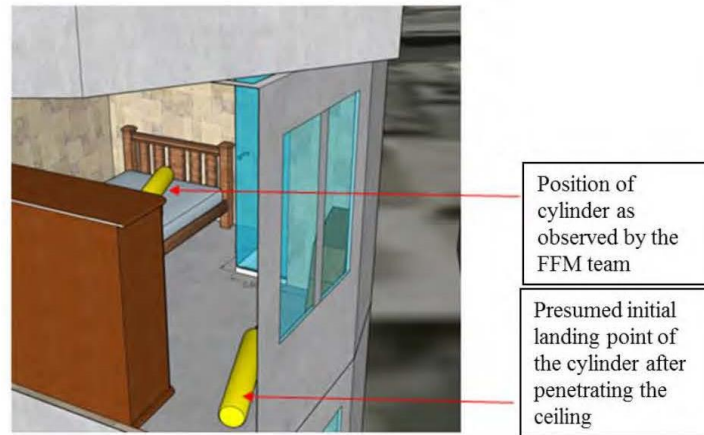
**FIGURE 11: VIEW OF THE BEDROOM AND CYLINDER POSITION**

- 8.33 From what the team observed, there did not appear to be any leakage from the cylinder at the time the team visited the location. The team noted that a slat of wood was lying under the cylinder on the bed, part of which was taken as a sample. The slat of wood was damp and softened. No chlorine gas was detected in the room by the detection equipment used by the team. The laboratory analysis showed that the wood sample had the highest content of chlorinated organic compounds of all wood samples taken.

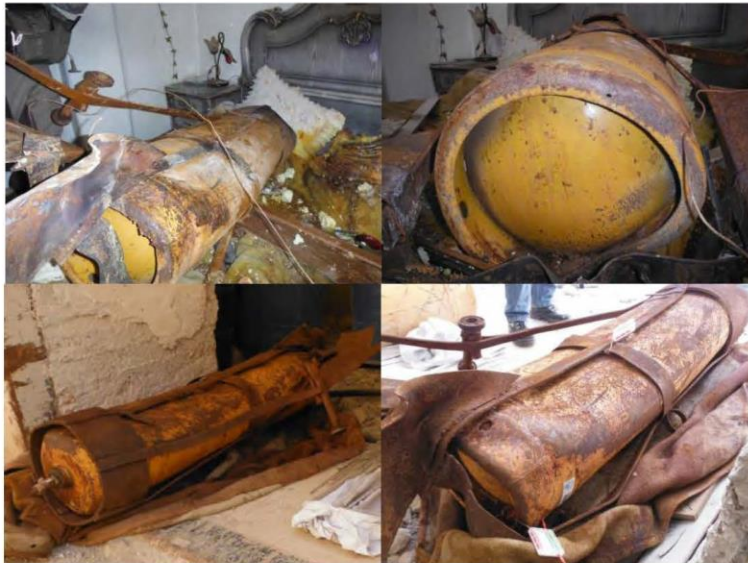
**FIGURE 14: DAMAGE OBSERVED ON THE CYLINDER**

- 8.35 In a similar manner, the FFM assessed the consistency between the structural damage appearing on the cylinder against the structural damage to the rebar-reinforced

concrete roof through which the cylinder allegedly traversed. Results are presented in Figures 13 and 14.

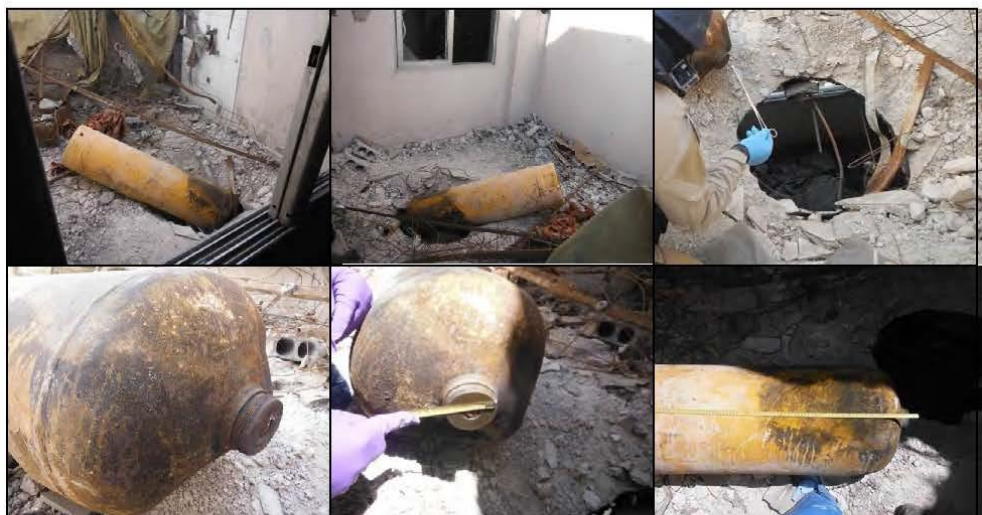
**FIGURE A.6.1 PHOTOS OF TERRACE, CRATER, AND ROOM BENEATH**

3. The aperture observed was circular in shape with approximately 45 degrees angular edges.
4. The mangled ironwork present on the patio indicated that there would have been a metallic frame and mesh covering it at one stage, though it was not clear whether this would have been present at the time of the alleged incident or had been demolished prior to that. The visual damage on the body of the cylinder indicates that the lateral aspect of the cylinder did not slide on the mesh but it hit perpendicularly.

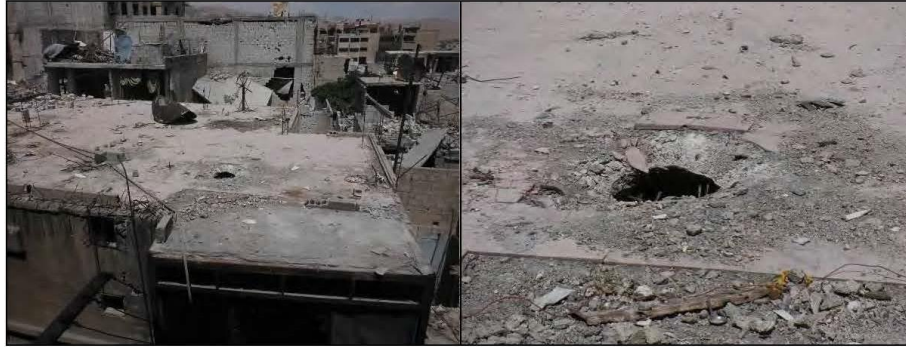
**FIGURE A.6.3 ADJACENT ROOF SHOWING A CRATER SIMILAR TO THE ONE ON THE ROOF TERRACE AT LOCATION 2**

5. The FFM team noted that a similar crater (see photos below) was present on a nearby building.

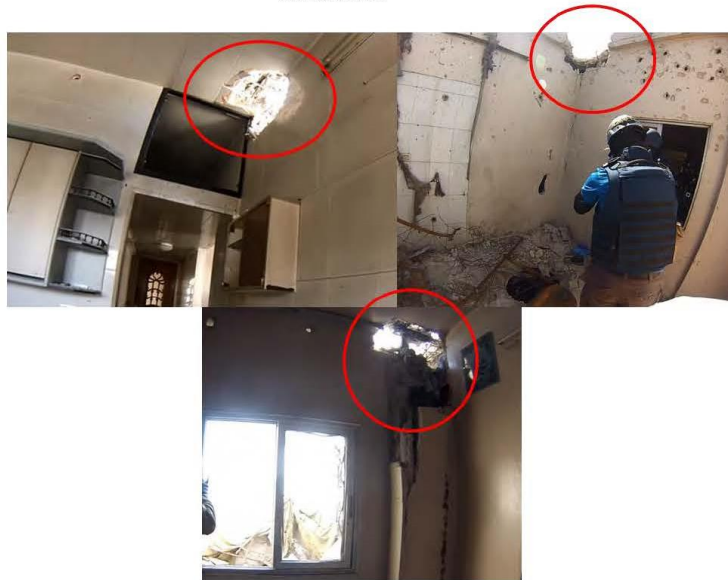
**FIGURE A.6.4 DAMAGE ABOVE THE CRATER OBSERVED FROM DIFFERENT ANGLES**

6. The team was not able to climb on to the top of the building due to the security restrictions, but was able to observe damage in the corner of the balcony location above the crater.

7. Observing the damage on the roof above the crater, the experts were able to provide an explanation of the cylinder not penetrating completely through the aperture. It can be seen that there was a large impact on the roof and walls above the balcony. The impact would decrease the velocity of the falling cylinder and changed its trajectory while hitting the concrete floor of the balcony causing a hole in it, but without sufficient energy to fall through it.

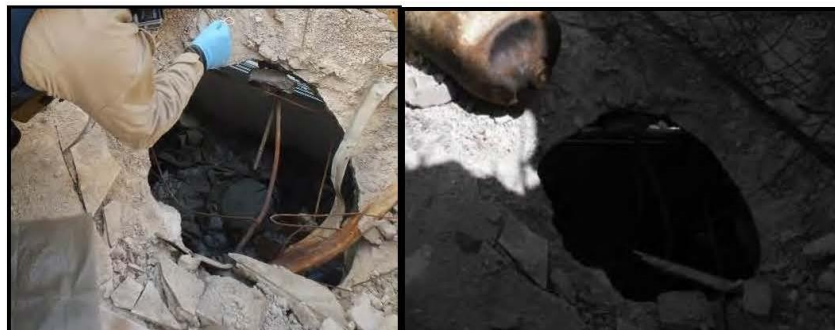
**FIGURE A.6.8 CRATER AS SEEN BY FFM INSPECTORS**

8. The FFM analysed the damage on the rooftop terrace and below the crater in order to determine if it had been created by an explosive device. However, this hypothesis is unlikely given the absence of primary and secondary fragmentation characteristic of an explosion that may have created the crater and the damage surrounding it.
9. The FFM team noted the blackening of the ceiling and the rim of the aperture from the room immediately below the point of impact (see photo above). It also noted the blackened sooty walls in the corner of the room, as well as what appeared to be the ashen remnants of a small fire. One interviewed witness stated that a fire had been lit in the room after the alleged incident, reportedly to detoxify it of the alleged chemical.

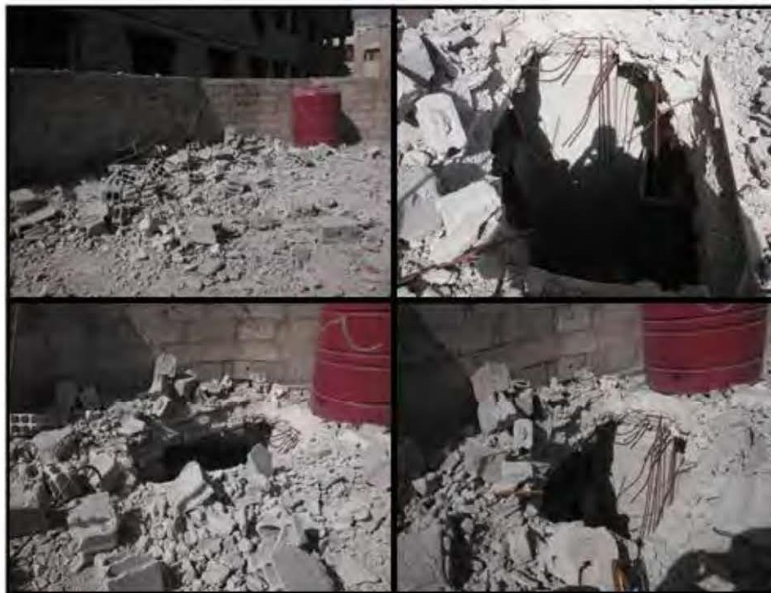
FIGURE A.7.4 CRATER ON THE ROOF OF LOCATION 4

The aperture was located close to a surrounding wall and next to the water tank with approximate dimensions of 166 x 105 cm. The distance from the adjacent building varies between 230 cm and 250 cm.

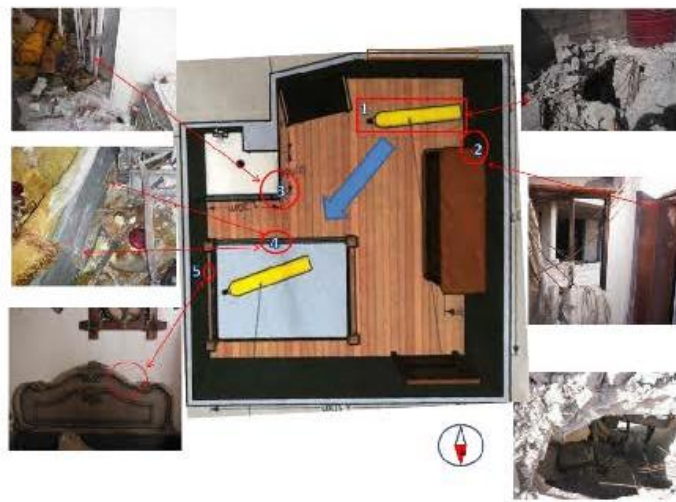
**FIGURE A.7.7: POSSIBLE TRAJECTORY OF THE CYLINDER INSIDE THE ROOM**

Considering the proximity of the water tank, the neighbouring buildings, and the surrounding wall adjacent to the hole in the roof, it was concluded that the cylinder impacted the roof as shown in Figure A.7.6. From the shape of the crater and damage on the cylinder, it is likely that the cylinder landed parallel to the ground creating a crater with dimensions of approximately 166 x 105 cm, which is in keeping with the dimensions of cylinder of 140 x 35 cm. It should be noted that the cylinder had an additional structure attached to the body, which is still in line with the dimensions of the crater. The damage observed on site by the FFM team and the possible trajectory of the cylinder based on observed damage and numerical calculations are represented in Figure A.7.7.

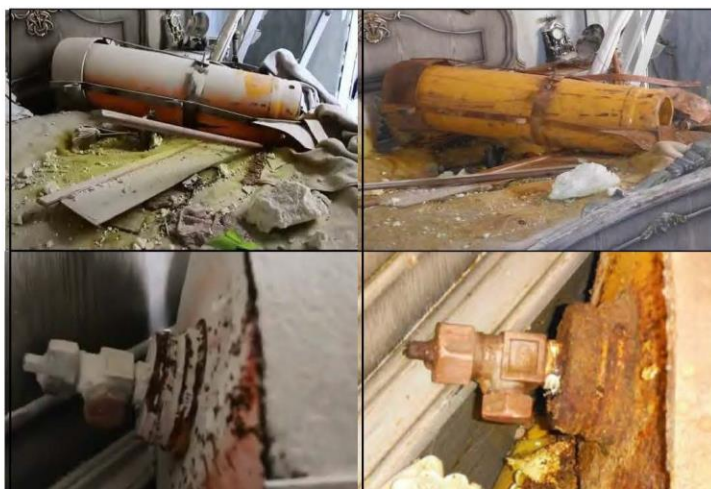
**FIGURE A.7.8 CHANGES IN THE SCENE**

The team observed some differences in the state and content, as well as location of certain items in the room, when referenced to open source videos released shortly after the alleged event. The observed changes are listed below:

- The bedside lamp on the right side (towards the window) had been moved and was also missing in some photos.
- The FFM team observed a viscous liquid throughout the room, which was not apparent in videos. The same liquid was observed also before the entrance to the apartment and on disposable gloves present at the location (Annex 5).
- The round object similar to the funnel cap found at Location 2 was seen on the open source video.

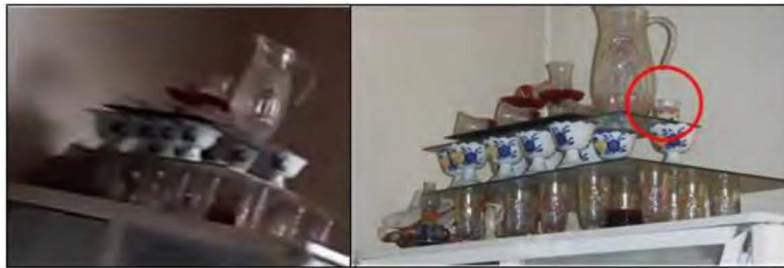
FIGURE A.7.10 OTHER DISCREPANCIES

- Another discrepancy observed while comparing open source videos issued before the FFM visit is related to the cup on the shower cabin. In the initial videos, the cup was not present but on the photos and videos taken by the FFM, the cup is visible.
