Preliminary report

Crash involving Malaysia Airlines Boeing 777-200 flight MH17

Hrabove, Ukraine - 17 July 2014

The Hague, September 2014

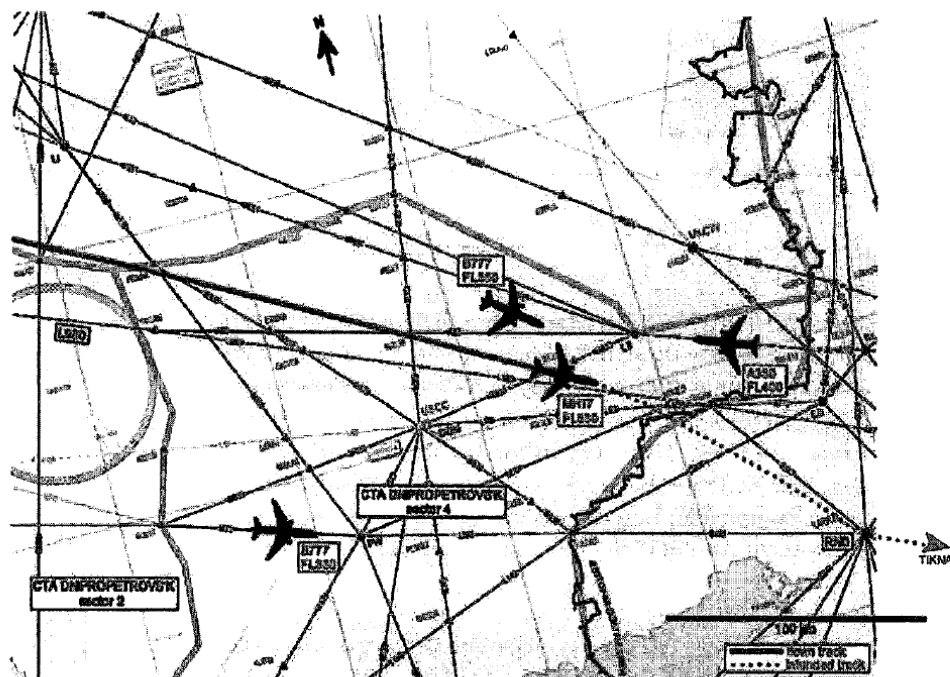
Data from the Flight Data Recorder and the Digital Cockpit Voice Recorder both stopped at 13.20:03 hrs. No distress messages were received from the aircraft.

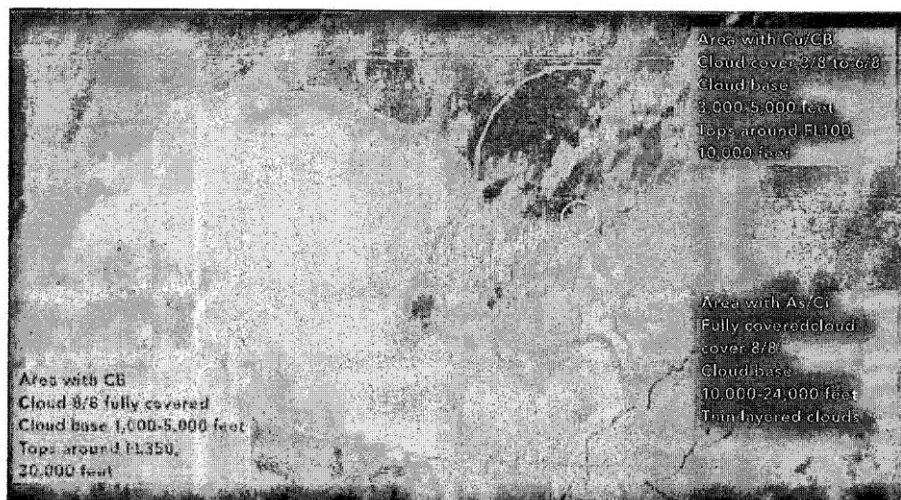
Figure 3: Cloud coverage for 17 July at 12.00 hrs.¹⁰ The circled green dot indicates the last position of aircraft. The orange area south-west of the accident location contains mostly Cumulonimbus clouds with possible thundershowers. (Source: KNMI)

The orange area contains mainly Cumulonimbus clouds (rainclouds). The cloud coverage is mostly 8/8. The cloud base is around 3,000 to 5,000 feet, with the tops of the clouds reaching FL350 (35,000 feet).

The red area contains mainly Altostratus and Cirrus clouds, with cloud coverage being mostly 8/8, and the cloud base around 10,000 to 20,000 feet. The red area contains mostly thin layered clouds reaching 20,000 to 30,000 feet at places.

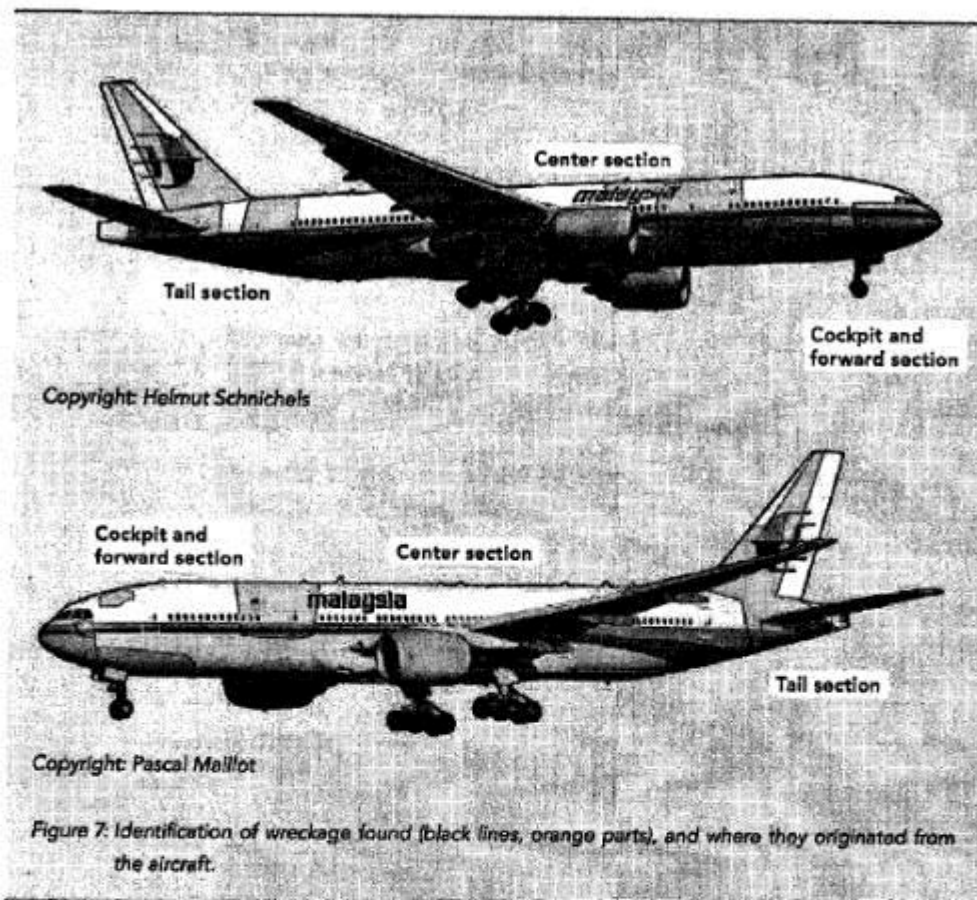
Some pictures of relevant parts of which the location was known, are discussed hereinafter.

Large parts from around the cockpit and forward section were found in the area closest to the last recorded FDR position (figure 6). Among these parts were portions of the cockpit, the forward cargo bay floor and the cockpit side wall. The remains of the cockpit were located at the southern end of Rozsypna, 2.3 km east from the last recorded FDR position.
