**Letter dated 4 March 2019 from the Secretary-General addressed to the President of the Security Council**

**Note by the Technical Secretariat**

**Report of the fact-finding mission regarding the incident of alleged  
use of toxic chemicals as a weapon in Douma, Syrian Arab  
Republic, on 7 April 2018**

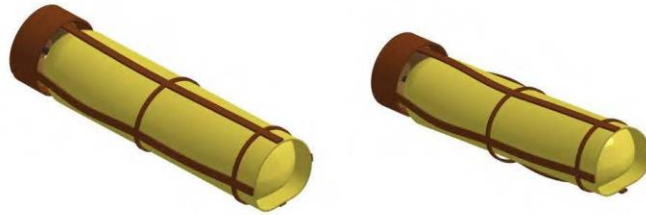
**FIGURE 13: COMPUTER-MODULATED DAMAGE TO THE CYLINDER WHILE PASSING THROUGH THE ROOF**

- 8.35 In a similar manner, the FFM assessed the consistency between the structural damage appearing on the cylinder against the structural damage to the rebar-reinforced

concrete roof through which the cylinder allegedly traversed. Results are presented in Figures 13 and 14.

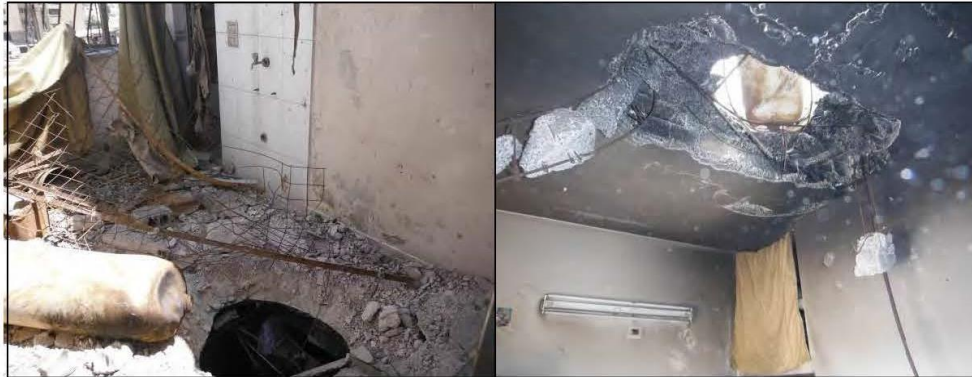
**FIGURE A.6.2 CYLINDER WITH VISIBLE DAMAGE LIKELY ORIGINATING FROM THE MESH**

3. The aperture observed was circular in shape with approximately 45 degrees angular edges.
4. The mangled ironwork present on the patio indicated that there would have been a metallic frame and mesh covering it at one stage, though it was not clear whether this would have been present at the time of the alleged incident or had been demolished prior to that. The visual damage on the body of the cylinder indicates that the lateral aspect of the cylinder did not slide on the mesh but it hit perpendicularly.

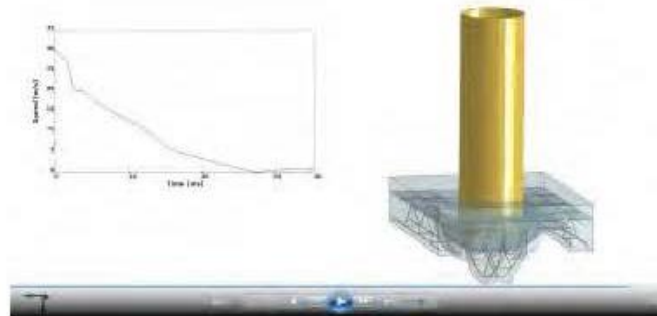
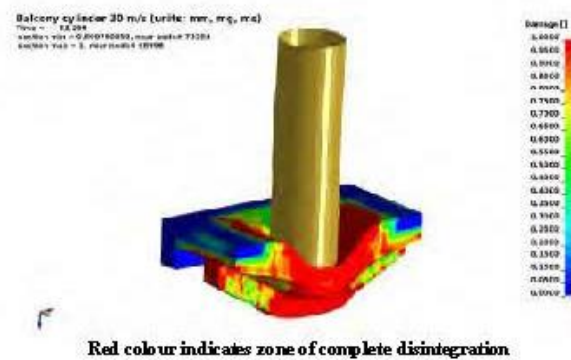
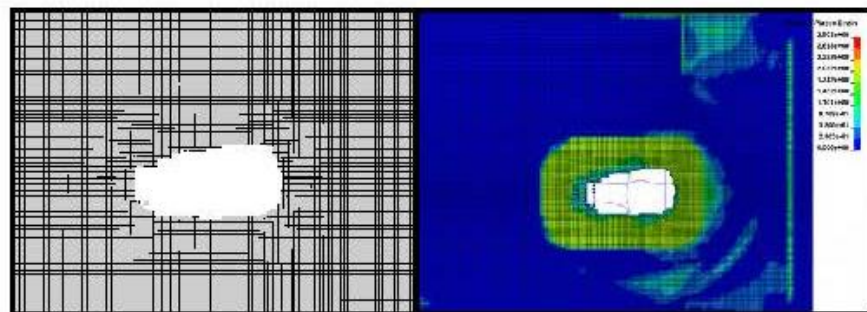
FIGURE A.6.7(a) MODULATION OF CYLINDER IMPACT ON BALCONY CEILING

FIGURE A.6.7(b) DAMAGE ON THE CEILING IN THE CASE OF LOW SPEED IMPACT

FIGURE A.6.7(c) NUMERICAL MODEL OF THE CRATER

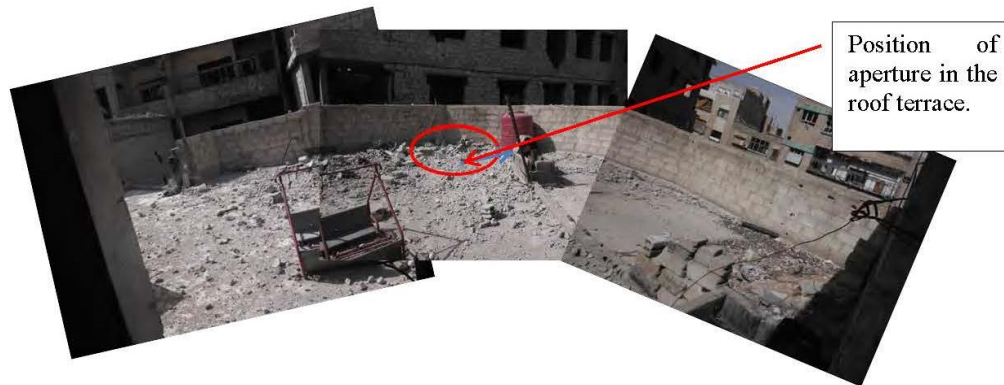
FIGURE A.7.3 ROOF OF LOCATION 4

The aperture was located close to a surrounding wall and next to the water tank with approximate dimensions of 166 x 105 cm. The distance from the adjacent building varies between 230 cm and 250 cm.

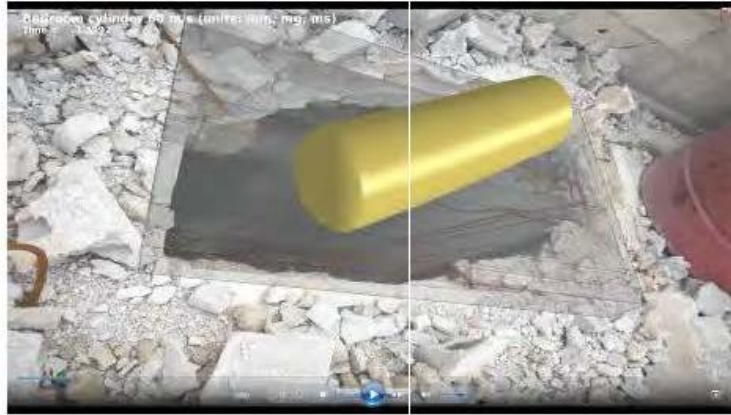
**FIGURE A.7.6 SNAPSHOT OF SIMULATION OF THE POSSIBLE ROOF CRATER FORMATION**

Considering the proximity of the water tank, the neighbouring buildings, and the surrounding wall adjacent to the hole in the roof, it was concluded that the cylinder impacted the roof as shown in Figure A.7.6. From the shape of the crater and damage on the cylinder, it is likely that the cylinder landed parallel to the ground creating a crater with dimensions of approximately 166 x 105 cm, which is in keeping with the dimensions of cylinder of 140 x 35 cm. It should be noted that the cylinder had an additional structure attached to the body, which is still in line with the dimensions of the crater. The damage observed on site by the FFM team and the possible trajectory of the cylinder based on observed damage and numerical calculations are represented in Figure A.7.7.

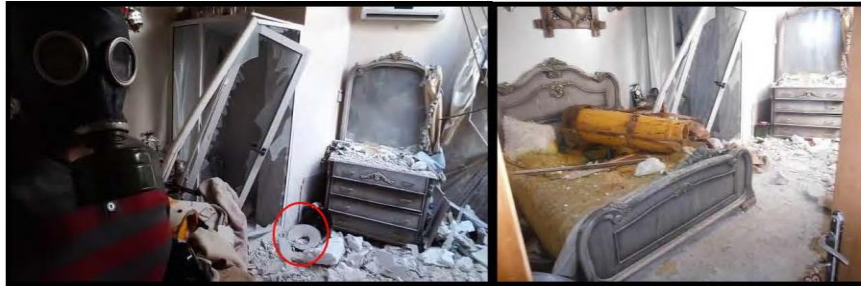
FIGURE A.7.9 FUNNEL CAP

- The bedside lamp on the right side (towards the window) had been moved and was also missing in some photos.
- The FFM team observed a viscous liquid throughout the room, which was not apparent in videos. The same liquid was observed also before the entrance to the apartment and on disposable gloves present at the location (Annex 5).
- The round object similar to the funnel cap found at Location 2 was seen on the open source video.

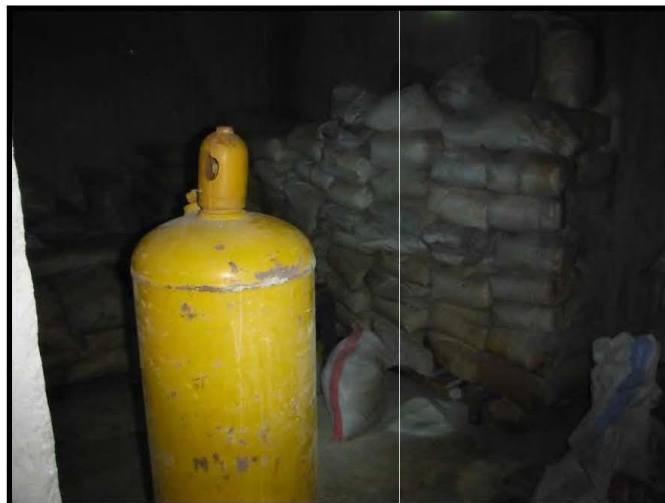
**FIGURE A.8.2 CYLINDER OBSERVED BY THE FFM TEAM AT THE WAREHOUSE**

7. Although the team confirmed the presence of a yellow cylinder in the warehouse, reported in Note Verbale of the Syrian Arab Republic (Annex 10, point 2) as a chlorine cylinder, due to safety reasons (risk involved in manipulating the valve of the cylinder, see Figure A.8.2) it was not feasible to verify or sample the contents. There were differences in this cylinder compared to those witnessed at Locations 2 and 4. It should be noted that the cylinder was present in its original state and had not been altered. Chlorine gas is generally not a common chlorinating agent in the production of chemical weapons agents, except when used in conjunction with phosphorous trichloride, which was not present. Subsequently, the presence of a cylinder reported as containing chlorine gas is not indicative of the production of explosives.

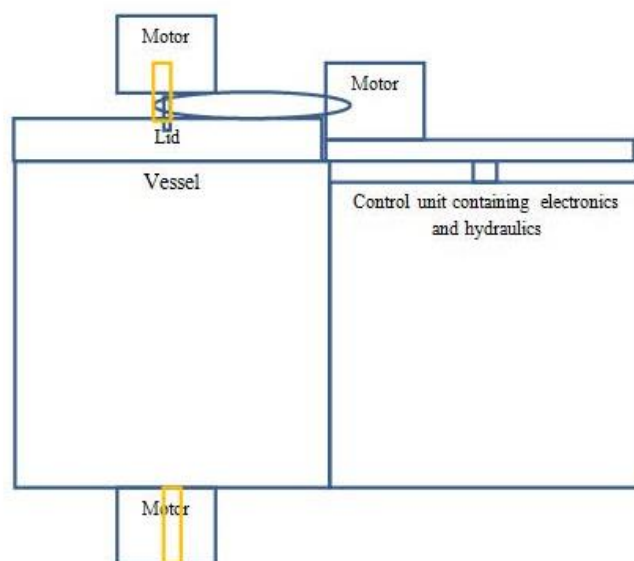
FIGURE A.8.5 SCHEME OF MIXING VESSEL

12. The mixing vessel was of a specific design, and the team considered that these design features did not make the unit particularly suited for chemical synthesis of toxic or any other chemicals. The installation appeared to be a heating and kneading unit that could be used for filling ammunition with liquid explosives or for mixing explosives with additives. Examples would include mixing of TNT with aluminium to produce tritonal, and mixing of RDX with liquid rubber for the production of plastic explosives.
